**COLORADO DEPARTMENT OF TRANSPORTATION  
INTERSTATE 70 VAIL PASS PAVING TRIAL UPDATE**

### Colorado Department of Transportation Interstate 70 Vail Pass Paving Trial Update

### **Eden's 1-Year In-Service Evaluation**

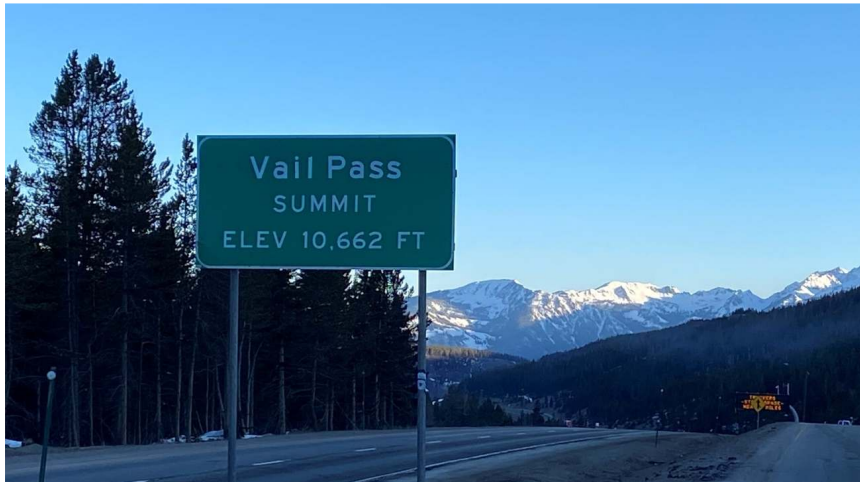
**Figure 1 – Vail Pass Summit on I-70**

IHC Scott placed approximately 600 yd<sup>3</sup> (460 m<sup>3</sup>) of concrete at a thickness of 6 inches (15 cm) in the drive lane at Mile Marker 184 on eastbound I-70. Each of the three mixes were placed in approximately 200 yd<sup>3</sup> (153 m<sup>3</sup>) increments that were laid over ~1000 linear feet (305 meters) (see Figures 1-3 below).

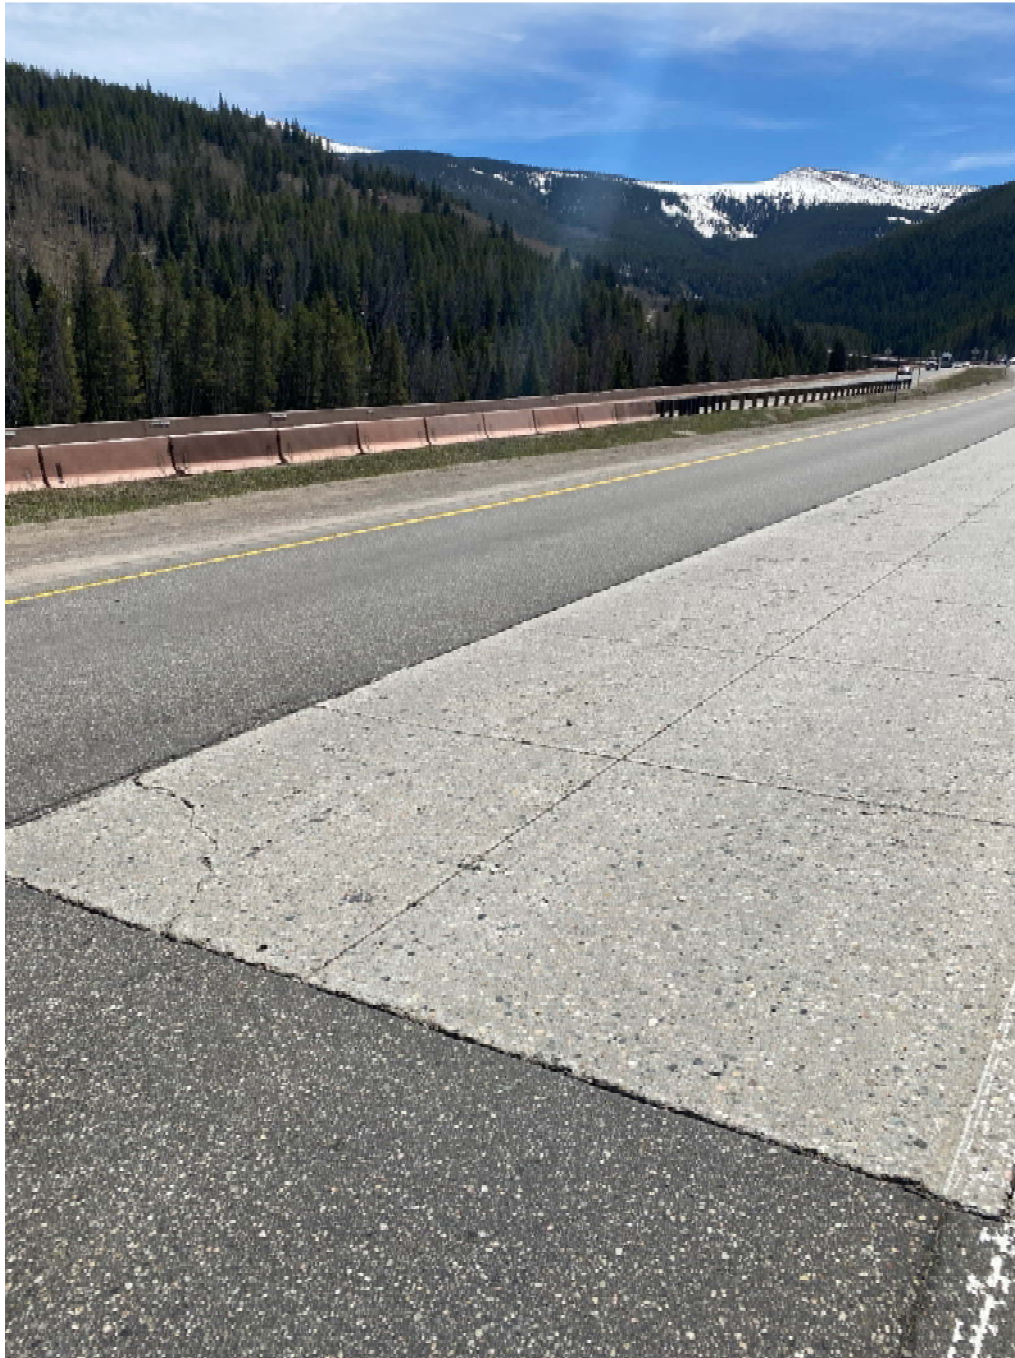
**Figure 4**

Beginning-Section Reference Slab -12 months

Top concrete surface worn off, Cracking, Scaling, Surface Aggregate Pop Outs, Rutting, Joint Rot

The Reference pavement has clearly deteriorated the most, as is reflected in the summary table with a 'yes' for all modes of deterioration and also in Figures 4-10.

Considering the pitting, small potholes, and shallow rutting already occurring, this section of pavement could require repair as it continues to deteriorate to a level which is unsafe for public and commercial vehicle traffic. The top surface of the pavement has abraded below the surface of the coarse aggregate from edge to edge and along the entire length of the reference section. There is a large crack across one section of the reference pavement and there is damage from snow chains across the entire surface.

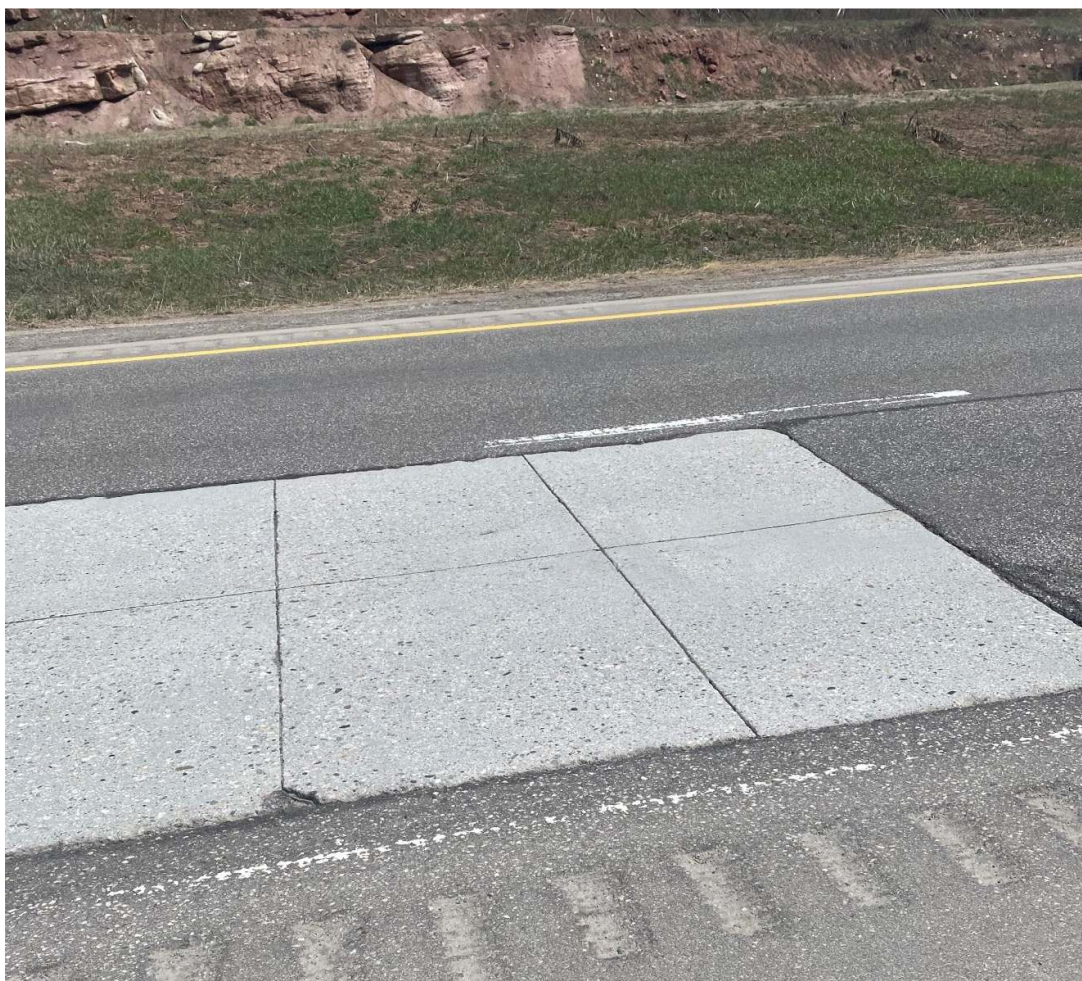
**Figure 20**

End-Section Silica Fume Slab - 12 months

Top concrete surface partially worn off, Scaling, Pitting and Aggregate Pop Outs, Joint Rot

The silica fume pavement has also deteriorated significantly, as is also reflected in the summary table with a 'yes' for 4 of 5 modes of deterioration, and also in Figures 16-20. Similar to the reference, the top surface of the pavement has scaled to the point of delamination and the surface has abraded below the surface of the coarse aggregate across the entire surface. There is also a large crack across one section of the silica fume pavement. Snow chains are also damaging the surface to the point of rutting.
