# Maritime Drills 5.5 gpt Gold over 29.8 metres, Including 73.0 gpt Gold over 1.5 metres at the Hammerdown Gold Project

Toronto, Ontario--(Newsfile Corp. - April 17, 2025) - **Maritime Resources Corp. (TSXV: MAE) (OTC Pink: MRTMF) ("Maritime" or the "Company")** is pleased to announce additional drill results from a grade control drill program at the Hammerdown Gold Project. Hammerdown is located in the Baie Verte mining district of Newfoundland and Labrador, near the towns of King's Point and Springdale.

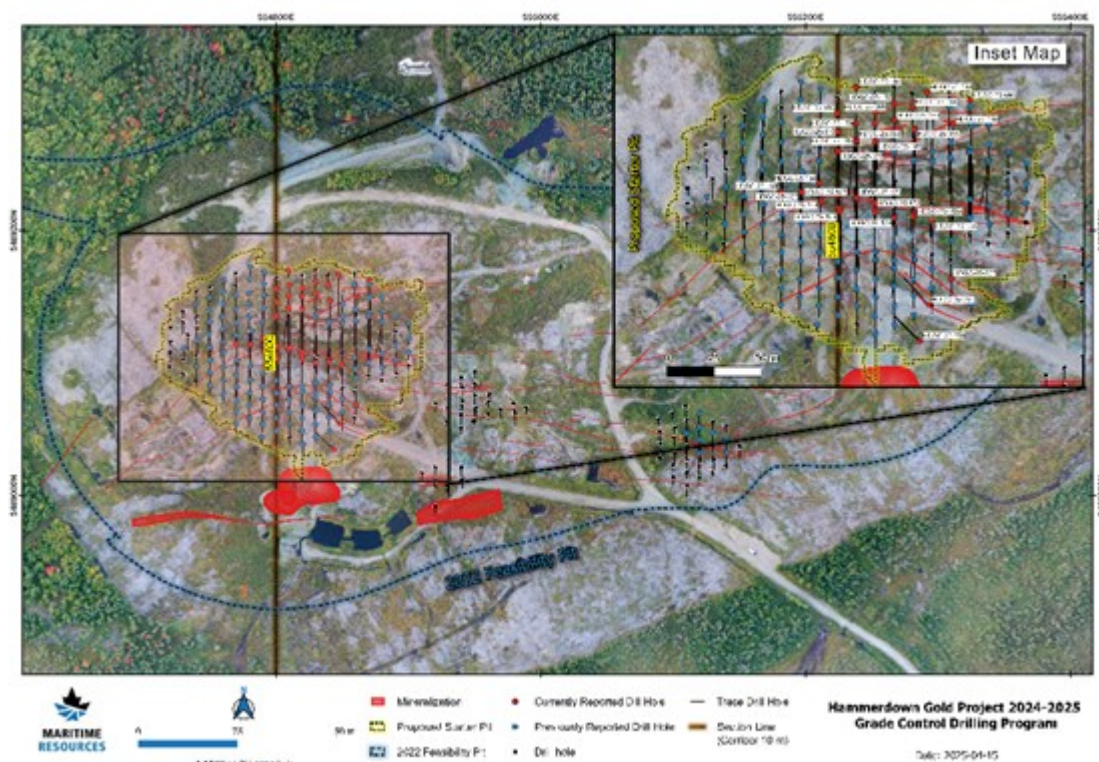
**Figure 1. Plan View**

The grade control drill program completed **8,460 metres of diamond drilling in 273 drill holes**. The program was designed to intersect the sub vertical mineralization on a 10 m x 10 m staggered pattern to maximize future ore extraction while minimizing ore losses and dilution. Assay results will be released as they become available.

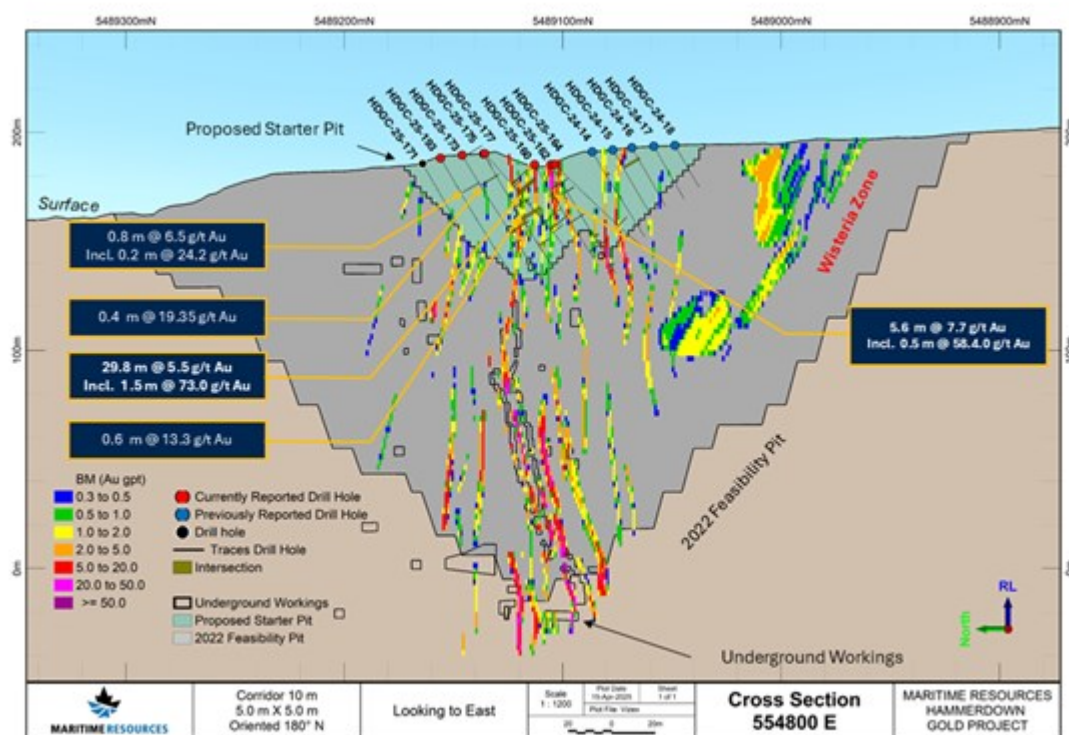
## Figure 2. Hammerdown Deposit Cross Section

The latest drill results cover the central portion of the proposed first year of open pit mining at Hammerdown. The grade control program continues to confirm the vein model and location of the historic underground workings while identifying additional mineralization between the high-grade veins, mine backfill material and remnant pillars. Notable assay results include drill hole HDGC-25-177 which intersected **5.5 gpt Au over 29.8 m, including 73.0 gpt Au over 1.5 m** related to a group of mineralized quartz veins and altered mineralized quartz feldspar porphyry (QFP) within the unmined crown pillar. Drill hole HDGC-25-160 was drilled 20 m south of drill hole HDGC025-177 and returned **7.7 gpt Au over 5.6 m**. Drill hole HDGC-25-188, located 20 m north of previously reported HDGC-25-118 (27.9 gpt Au over 1.0 m; see [Maritime press release dated March 14, 2025](#)), returned several high-grade gold intercepts. Highlights include 15.0 gpt Au over 1.4 m, 67.1 gpt Au over 0.9 m, and 14.6 gpt Au over 0.2 m.

The Hammerdown grade control program has identified high grade gold mineralization within the historic backfilled stopes. Drill hole HDGC-25-189 returned **14.8 gpt Au over 5.9 m** and HDGC-25-175 returned **17.0 gpt Au over 4.4 m**. These results enhance the confidence in the mineralization surrounding and inside the previously mined out stopes at Hammerdown. All backfill intervals drilled during the grade control program were sampled and resulted in the collection of 151 samples representing 274 linear metres of drilling with a **weighted average of 3.3 gpt Au** across a 1 m composite length. The backfill gold content is believed to be the result of a combination of the high historic mine cut-off grade as well as high grade loss on mining material remaining during the cut and fill mining process. The potential quantity and grade of the backfill material are conceptual in nature and there has been insufficient sampling to define a mineral resource. It is uncertain whether further sampling would result in the backfill material being delineated as a mineral resource.
