AMENDED AND RESTATED NATIONAL  
INSTRUMENT 43-101 TECHNICAL REPORT  
Castrovirreyna Project, Peru

**SILVER MOUNTAIN RESOURCES INC**

Effective Date: August 17, 2021

Mr Antonio Cruz Bermúdez, MAIG 7065

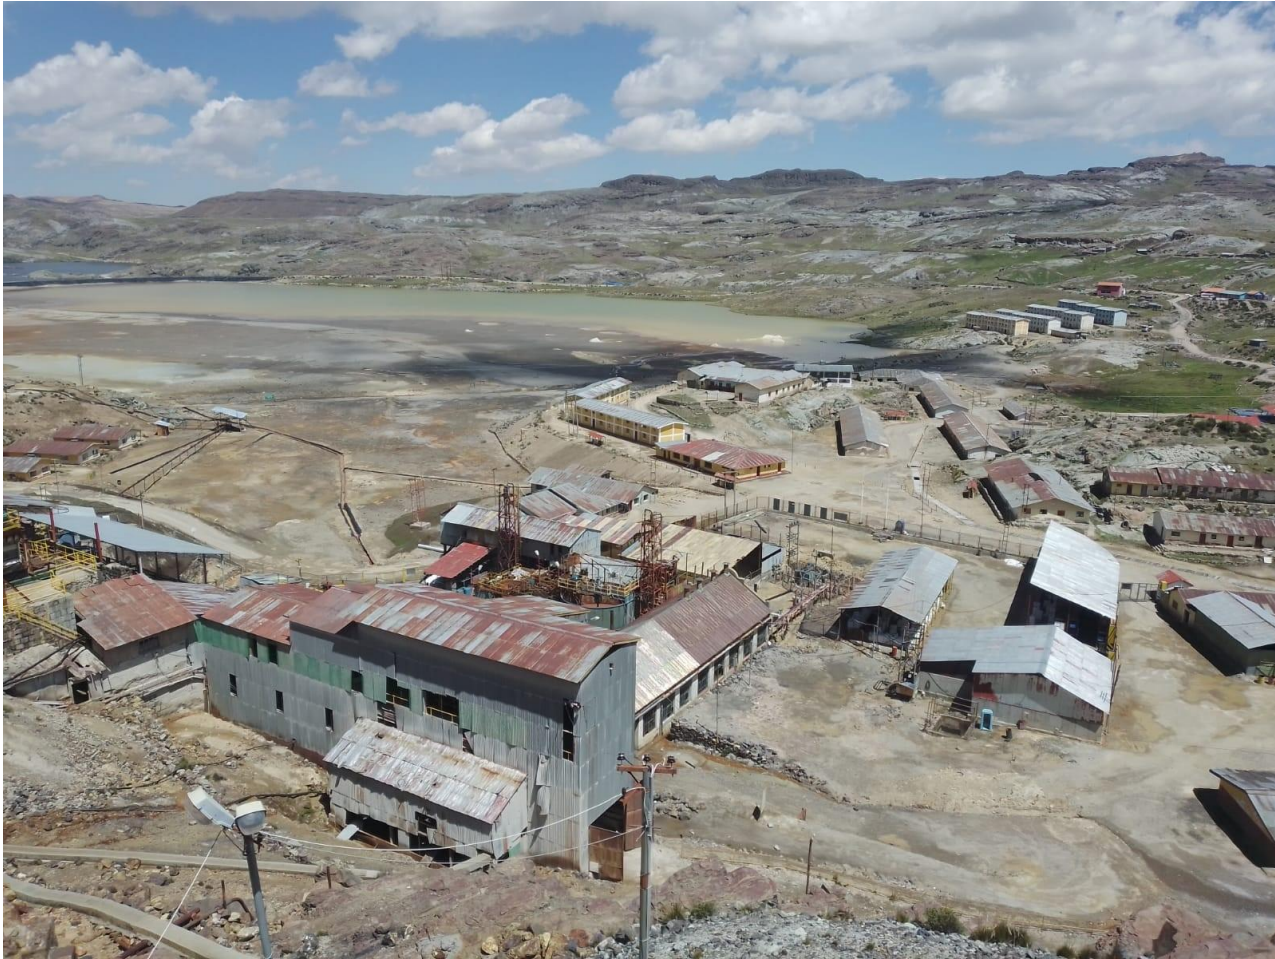
**Figure 5-2: General Project Infrastructure**

Note: Photograph provided by Minera Reliquias, 2021. Photograph looks southwest. View showing concentrator and storage buildings. Caudalosa 1 TSF and accommodations facilities in background.

Photographs illustrating the state of the infrastructure on site are provided in Figure 5-2 to Figure 5-6.

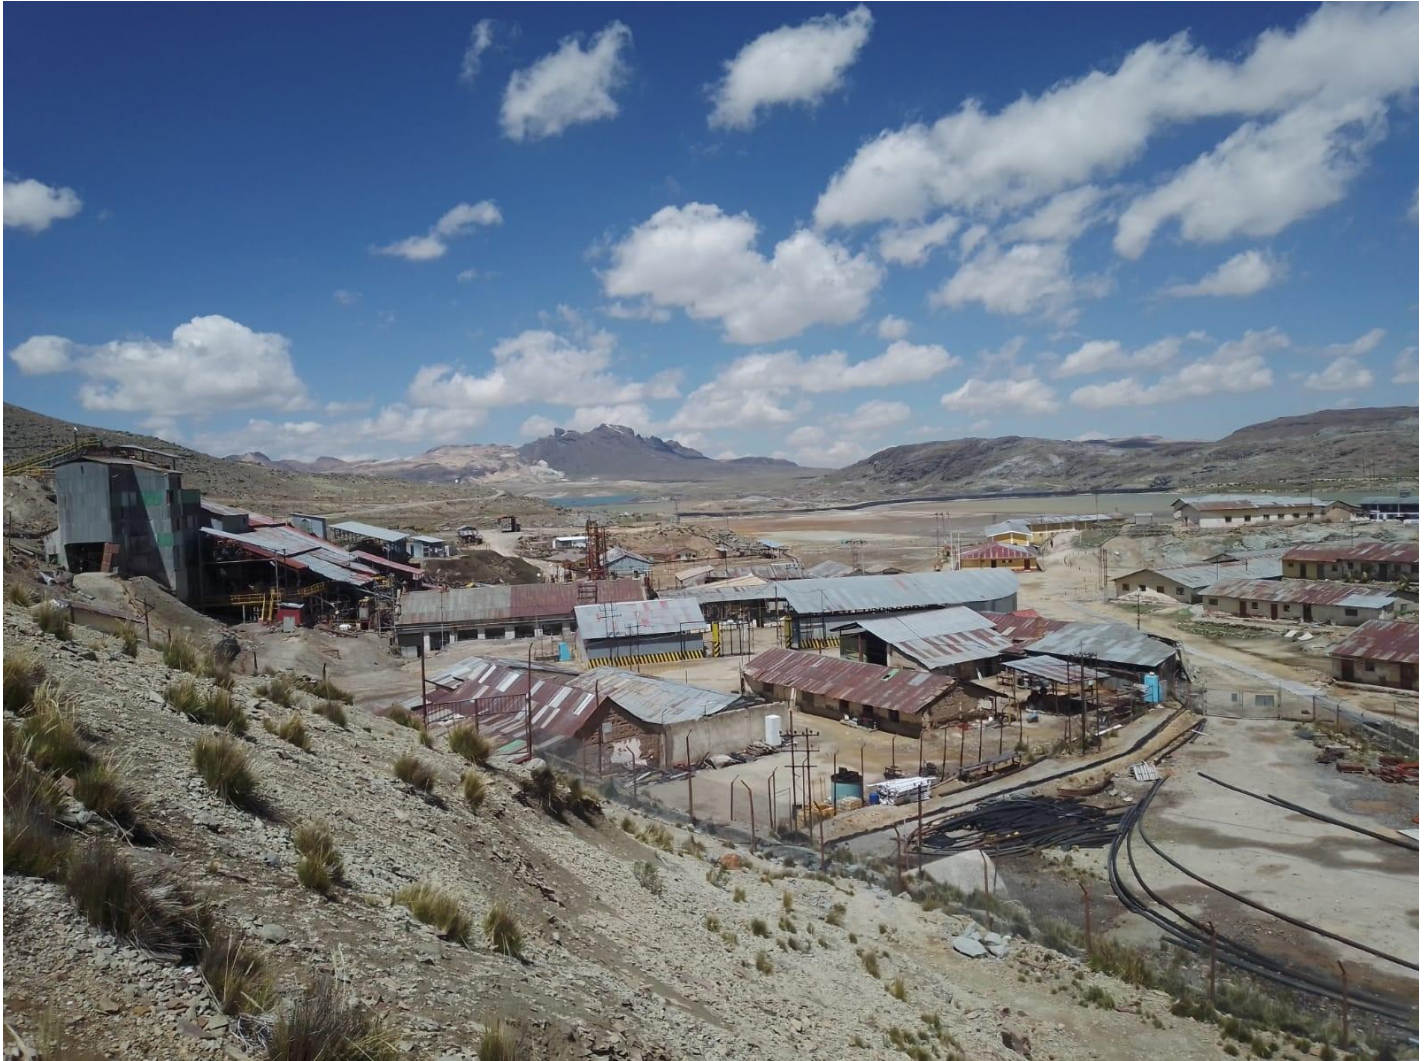
**Figure 5-3: General Project Infrastructure**

Note: Photograph provided by Minera Reliquias, 2021. Photograph looks south. View showing warehouse, concentrator, and storage buildings. Caudalosa 1 TSF in background.

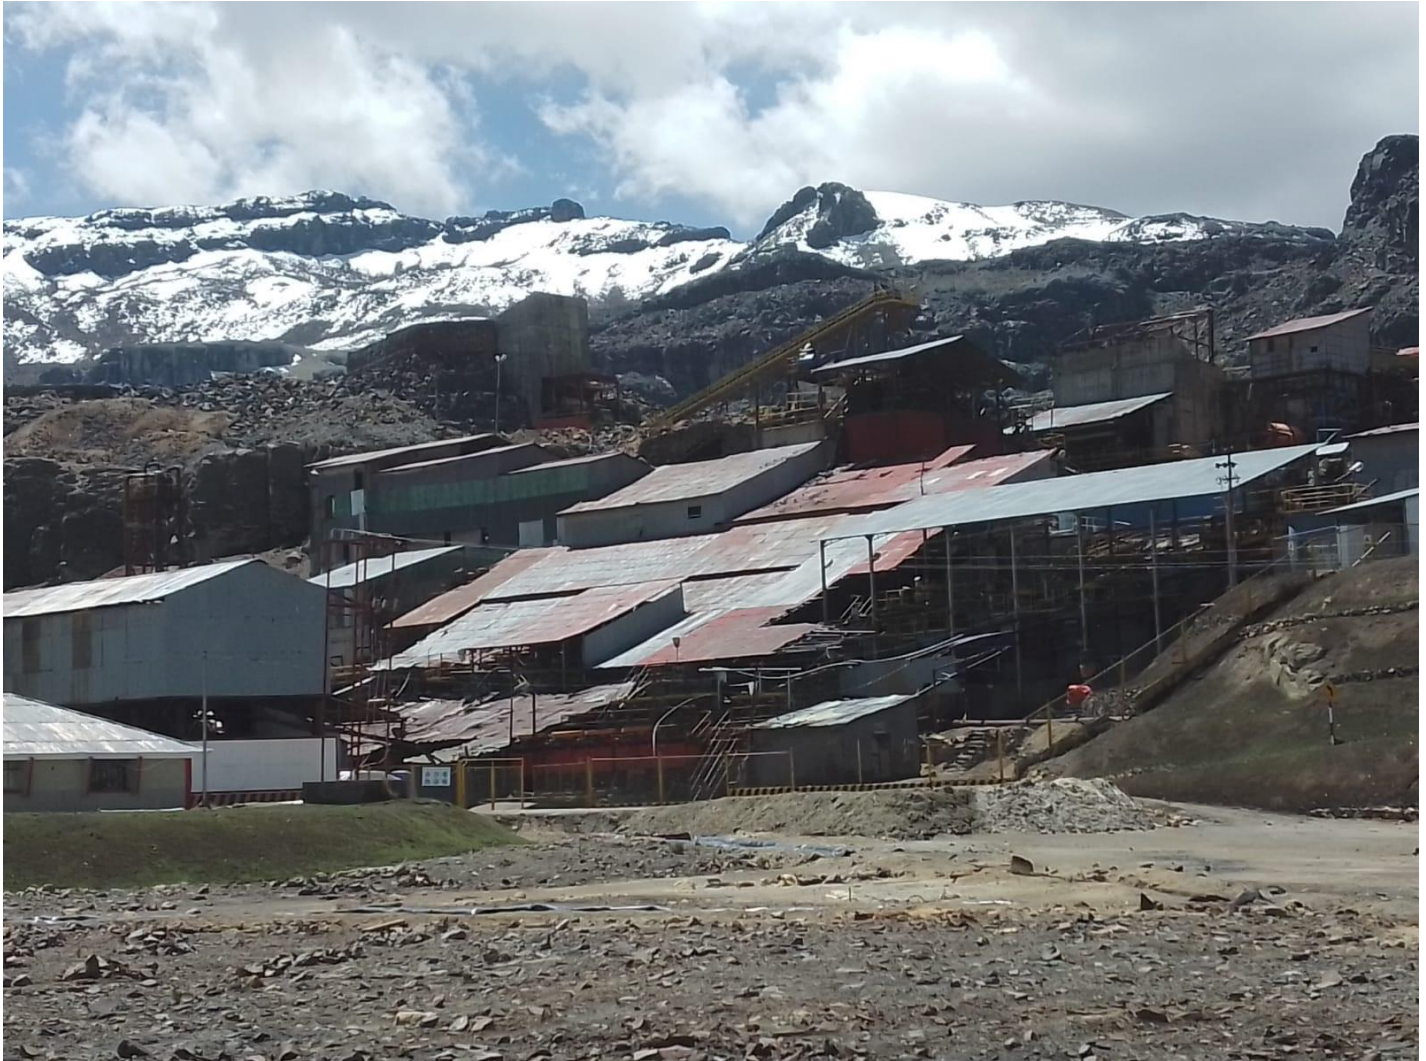
**Figure 5-4: Existing Concentrator**

Note: Photograph provided by Minera Reliquias, 2021. Photograph looks northeast. View of concentrator and process area.

Minera Reliquias also recommends moving ahead with the process of derisking the project by unlocking the current processing potential. This process will enable Minera Reliquias to start up operations faster, by restarting the existing concentrator in the mid term.

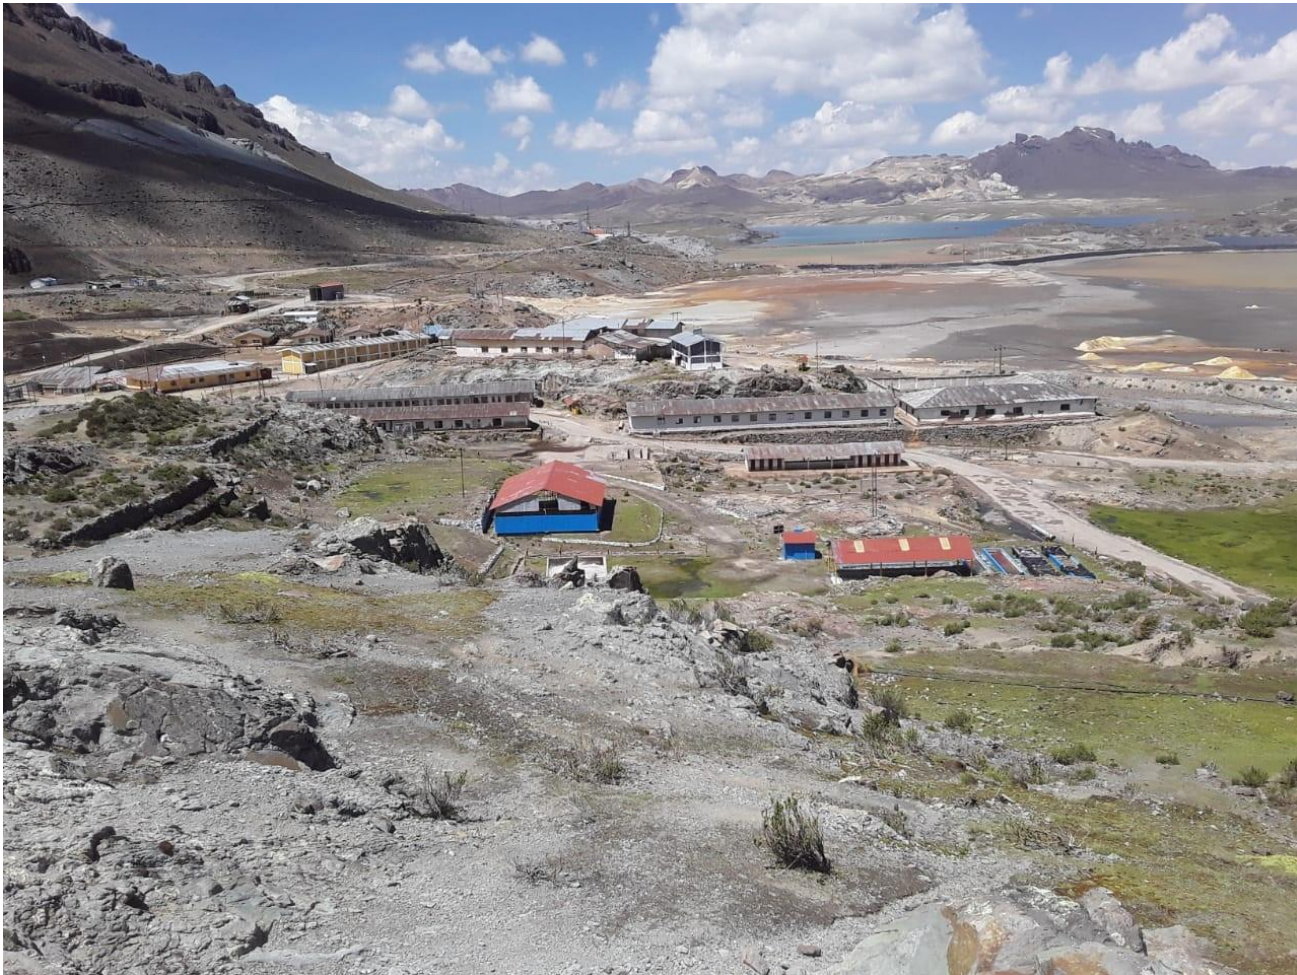
**Figure 5-6: Mine Site Buildings Overview**

Note: Photograph provided by Minera Reliquias, 2021. Photograph looks southeast. Mine buildings including offices, cafeteria, with Caudalosa 1 TSF and Caudalosa 2 TSF in background.

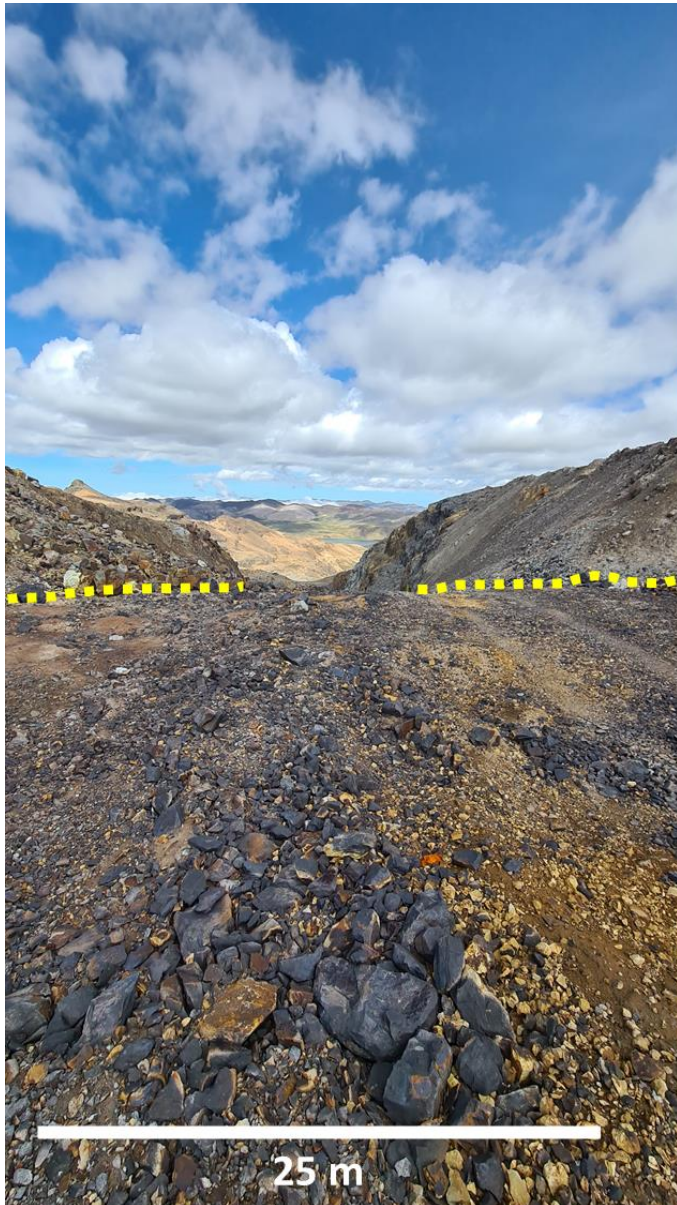
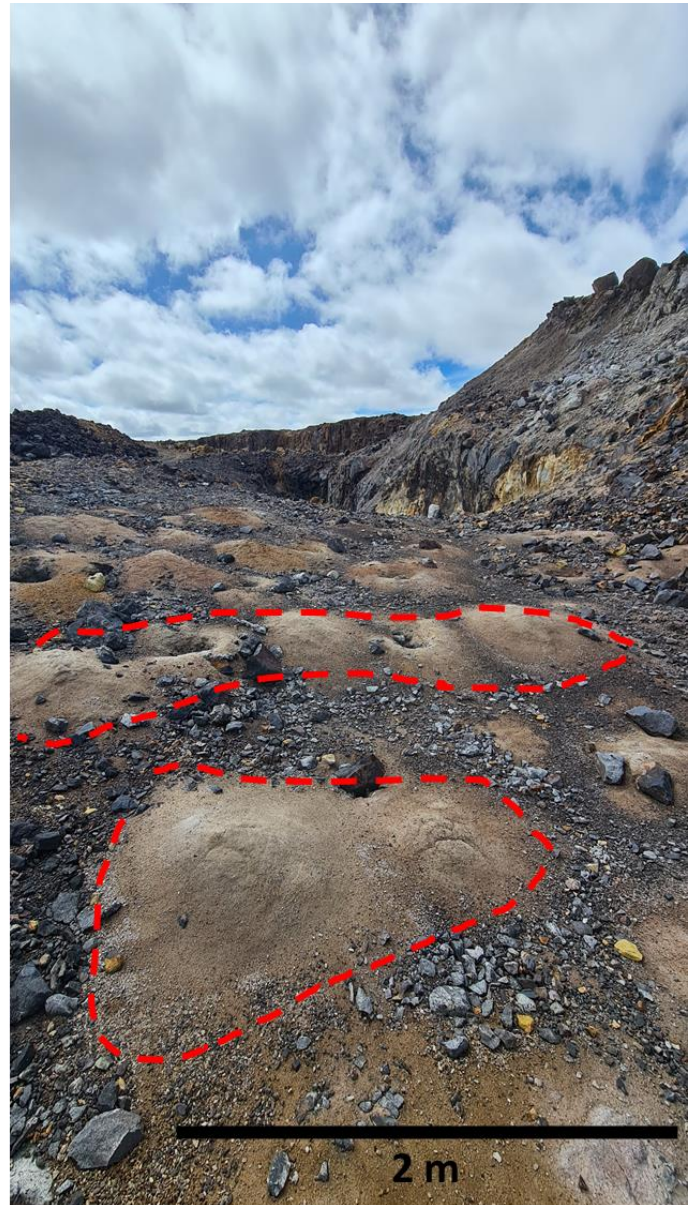
**Figure 12-3: Matacaballo Vein**

Note: Photograph taken on 2021 site visit. Image to the left, looking east, is of manganese-oxide coated quartz vein rubble. Image to the right shows Corporación Minera Castrovirreyna sample locations.

The Pasteur pit, excavated by Corporación Minera Castrovirreyna in the eastern end of the Matacaballo vein, was inspected. The pit is about 300 x 100 m in area (Figure 12 2). Moderate silica–argillic alteration was exposed. Quartz veins with disseminated sulphides, including galena, sphalerite, argentite and pyrite were visible. Manganese oxide coatings on veins was noted. Surface outcrops showed oxidized quartz vein material, and locations of blasthole samples taken by Corporación Minera Castrovirreyna were visible (Figure 12 3).

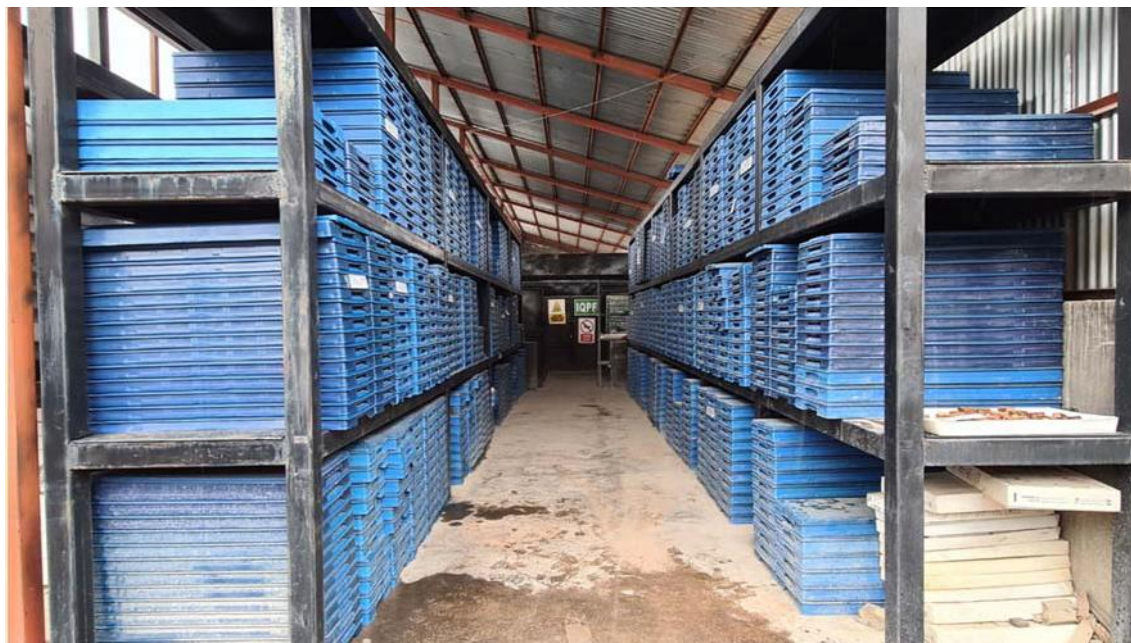
**Figure 12-5: Minera Reliquias Core Shed**

Figure 12 – 5 shows the core shack used by Minera Reliquias.. The core is under cover, accessible, and individual cores were able to be located. Core sampling was assessed to ensure a reasonable cutline was taken when halving the core for assay submission. No significant issues were noted from the review.
