# SOMA GOLD MOBILIZES SURFACE DRILL RIG TO THE EL LIMON MINE, ZARAGOZA, ANTIOQUIA, COLOMBIA

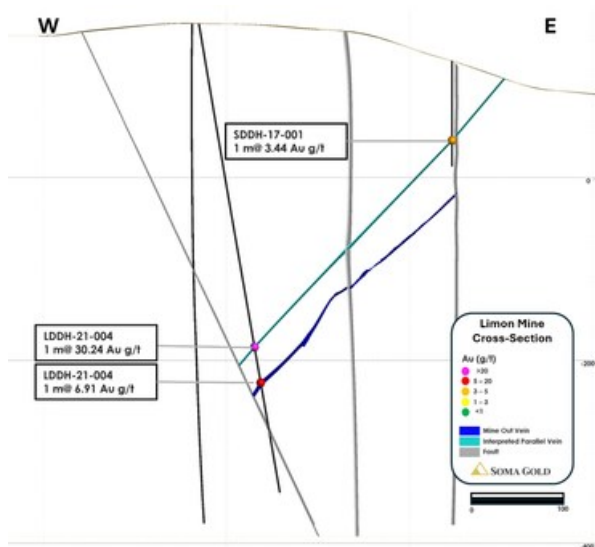
Figure 2: Cross-section of the El Limon Mine (CNW Group/Soma Gold Corp.)

The 2024 drilling program will begin with infill drilling down dip of drill hole SHD-17-01. Figure 2 presents a cross-section of El Limon that shows the spatial relationship between the mine and drill intercepts, with a parallel vein interpreted between drill holes SHD-17-01 and LDDH-21-004. The deeper intercept of 23 g/t Au in LDDH-21-004 interpreted to be the down dip extension of the El Limon vein. A deeper drill hole is planned to test this hypothesis later in 2024. No significant gold assays were intercepted in LDDH-21-008. However, the presence of barren quartz veins in the drill hole indicates the structure continues at depth.
